Electrostatic ignition of toluene vapours during vacuuming truck operation.

Operation: vacuuming of off-spec toluene from a sump.

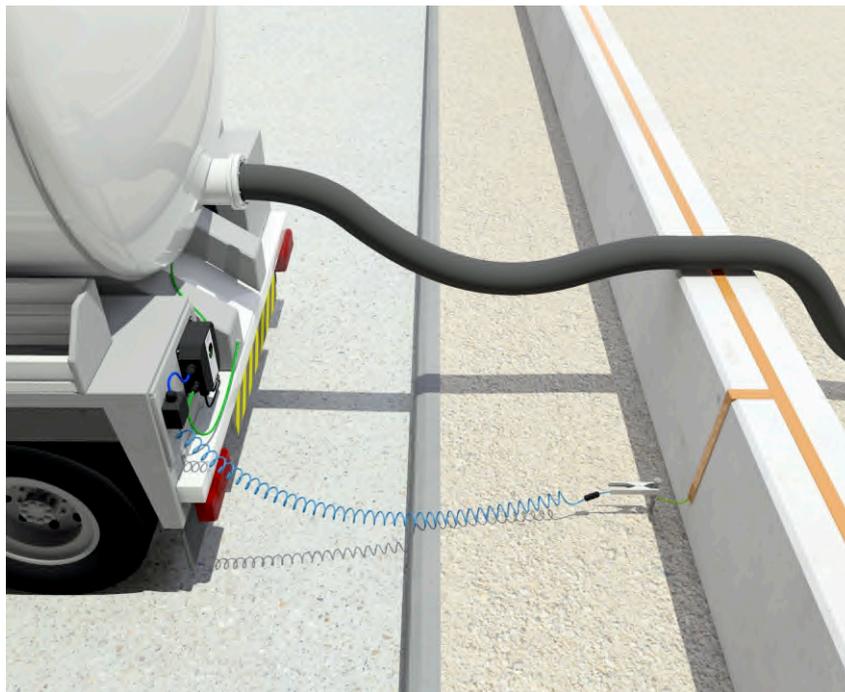
If a truck mounted grounding system had been used by the contractor providing waste removal service at the site in this case study, this fire would have been avoided. There are several benefits of using a truck mounted grounding system. One such example is the Earth-Rite® MGV.

- The Earth-Rite MGV automatically verifies if the truck is connected to a ground source that is connected to the mass of the earth.
- It will monitor the resistance between the verified ground source and the truck so that if exceeds 10 ohms the green LED indicators will switch from pulsing green to red.
- Internal dry contacts can be utilized to shut down the movement of liquid or powder if the Earth-Rite MGV detects that ground connection is not present.
- Site electricians do not need to perform a one-time check with a meter. The Earth-Rite MGV will not only perform this check automatically for the driver, it will continue to monitor the connection for the duration of the transfer operation.
